TRANSMITTAL MEMO

<p>Date: January 25, 2023</p> <hr/> <p>Item #: P23-015</p> <hr/> <p>Planner: Paul Anthony</p> <p>Phone: 733-0440 ext. 1305</p> <p>Email: panthony@jacksonwy.gov</p> <hr/> <p>Owner: Christopher Swann & Snake River Bend Ranch LLC 3060 Peachtree Rd. NW STE 1080 Atlanta, GA 30305</p> <p>Applicant: Jorgensen Associates, Inc. PO Box 9550 Jackson WY 83002</p>	<p style="text-align: center;">REQUESTS:</p> <p>Teton County is submitting a request for a Town of Jackson review of an Amended PUD and Development Plan associated with Snake River Canyon Ranch Resort located at 12455 S River Bend Rd, 985 W Elk Ridge Rd, and W Elk Ridge Road, PIDN: 22-39-16-32-4-01-005, 22-39-16-32-4-02-001; 22-39-16-32-4-02-002</p> <p>For questions, please call Paul Anthony at 733-0440, x1303 or email to the address shown below. Thank you.</p>
<p>Please respond by: February 15, 2023 (with Comments)</p>

PROJECT TITLE:
**SLAKE RIVER SPORTING CLUB
 LOT 23, THE RIVER HOMES
 SLAKE RIVER CANYON RANCH
 TETON COUNTY, WYOMING**

SHEET TITLE:
SITE PLAN

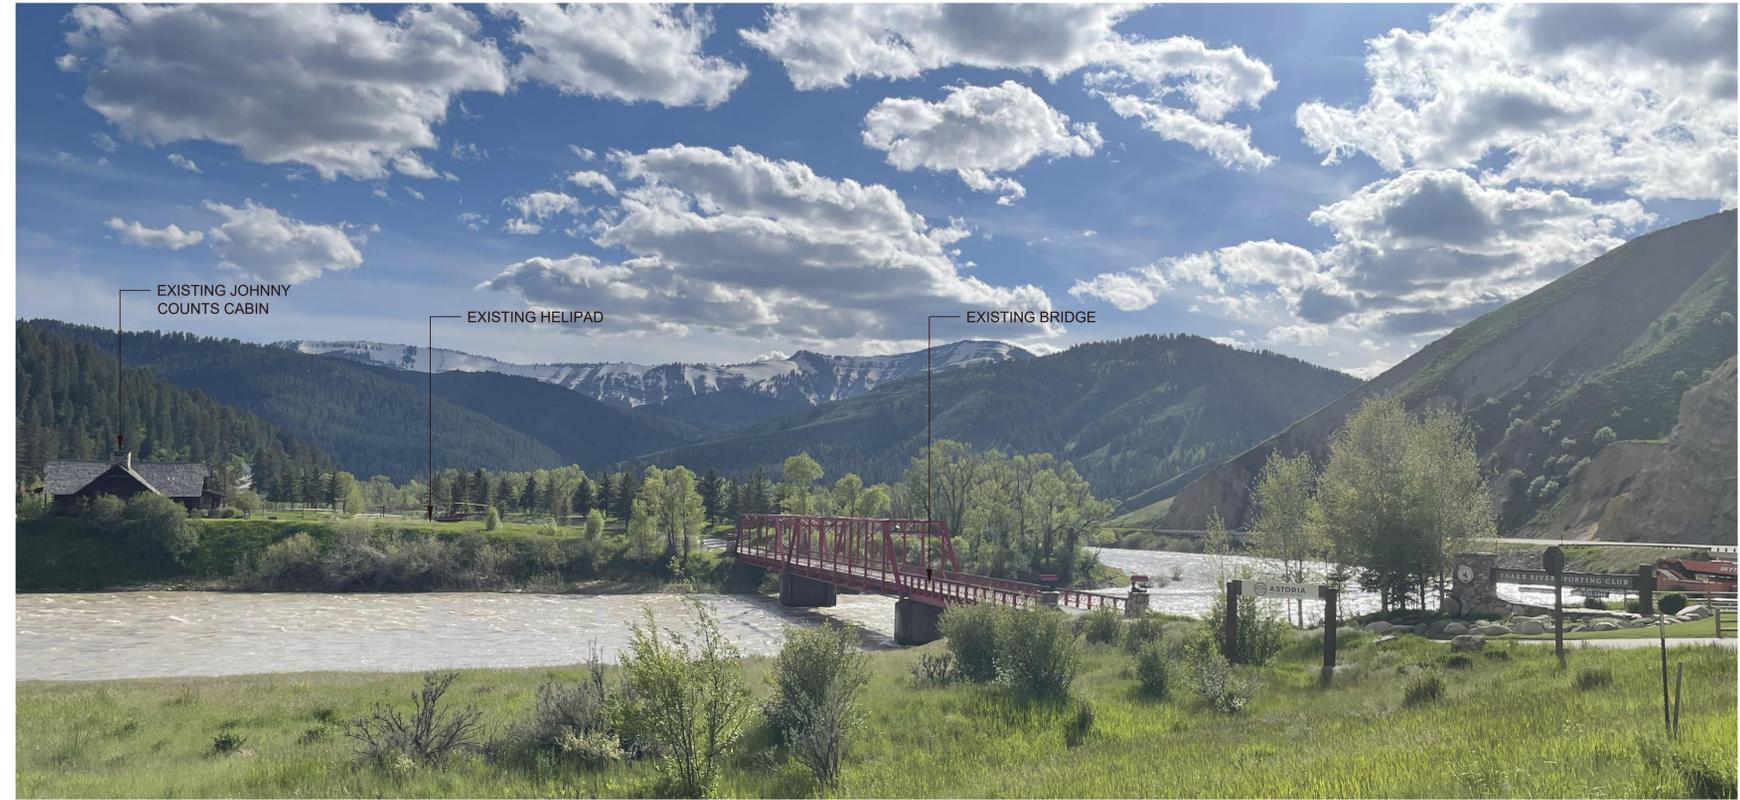
VIEW 1: EXISTING LANDSCAPE VIEW LOOKING SOUTHWEST

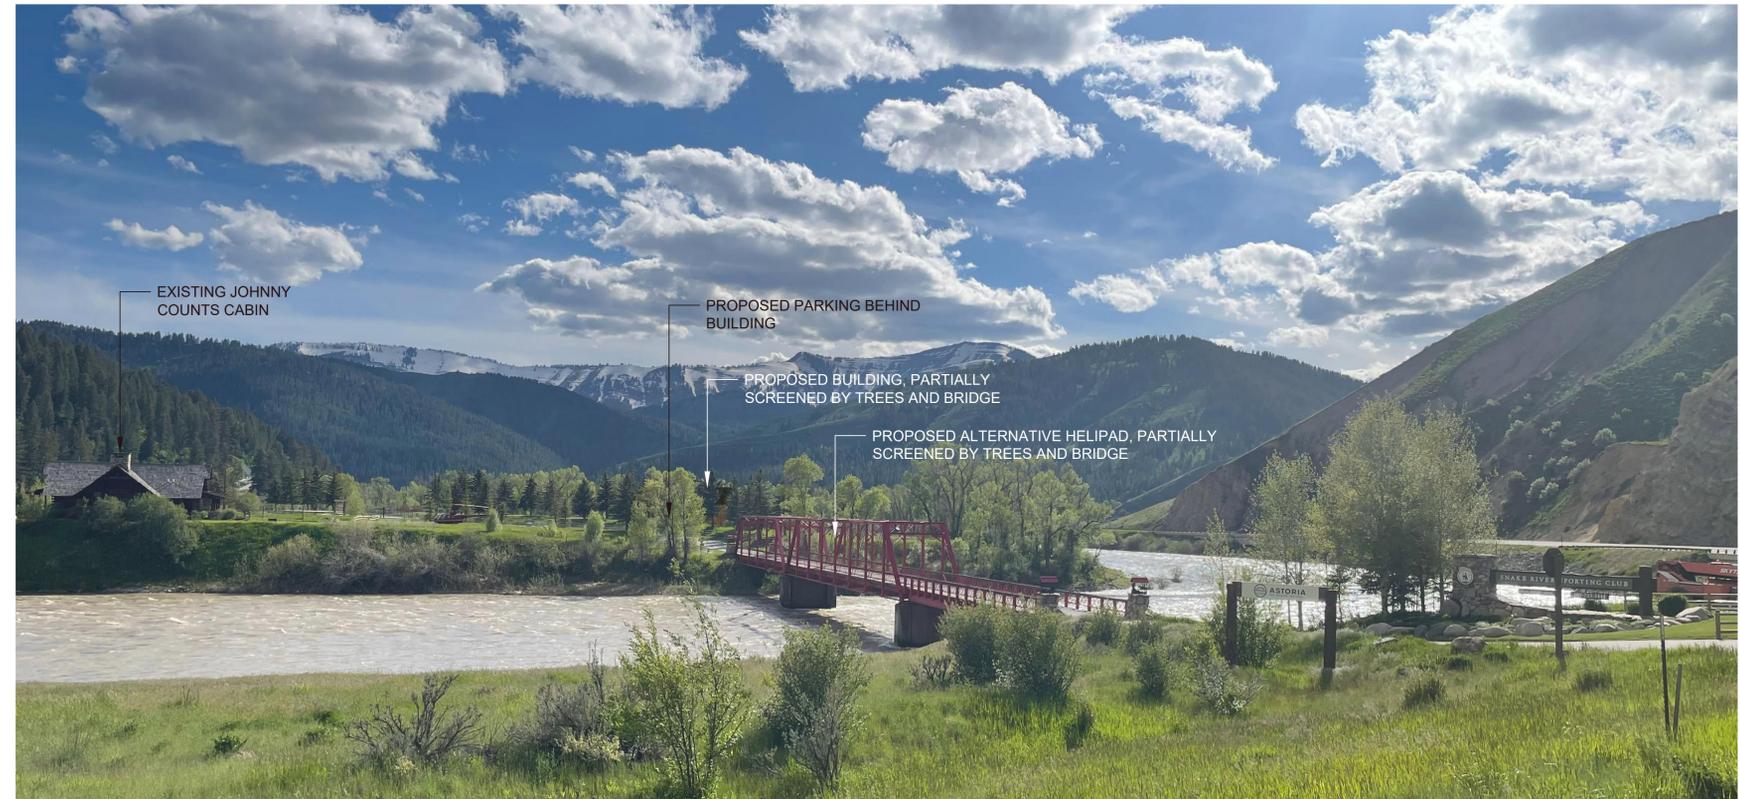
THE PROPOSED DEVELOPMENT PLAN FOR ASTORIA - SRSC EMPLOYEE HOUSING INCLUDES THE CONSTRUCTION OF PARKING LOT, CONNECTING ROAD, AND AN ALTERNATIVE HELICOPTER LANDING SITE ON A PREVIOUSLY DISTURBED AREA OF THE SITE (CURRENTLY GRAVEL MIXED INTO NATURALIZED GRASS). THE PARKING LOT, EXCLUSIVE TO SRSC EMPLOYEES, WILL CONTAIN ENOUGH SPACES FOR A RESIDENTIAL EMPLOYEE DWELLING; THE PATH, EITHER CONCRETE OR CRUSHED GRAVEL, WILL CONNECT THE EMPLOYEE HOUSING TO RIVERBEND ROAD; AND THE ADJACENT ALTERNATIVE HELICOPTER LANDING SITE WILL BE AVAILABLE FOR ANY NECESSARY MEDICAL EVACUATIONS, SCREENED AWAY FROM THE MAIN ROAD.

VIEW 1: PROPOSED LANDSCAPE VIEW LOOKING SOUTHWEST

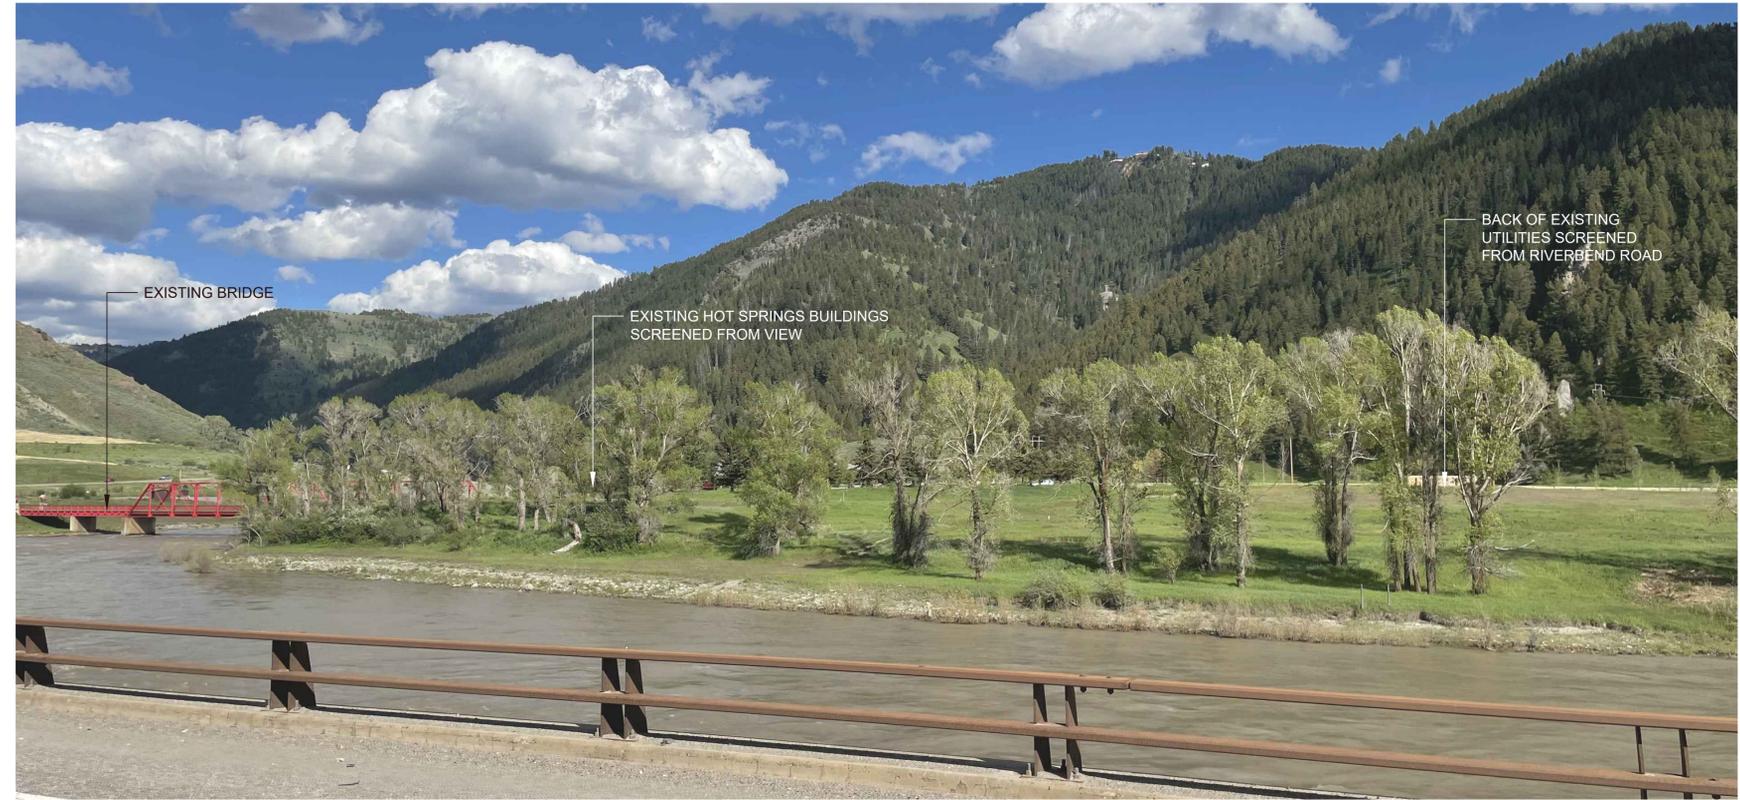
VIEW 2: EXISTING LANDSCAPE VIEW LOOKING SOUTHEAST

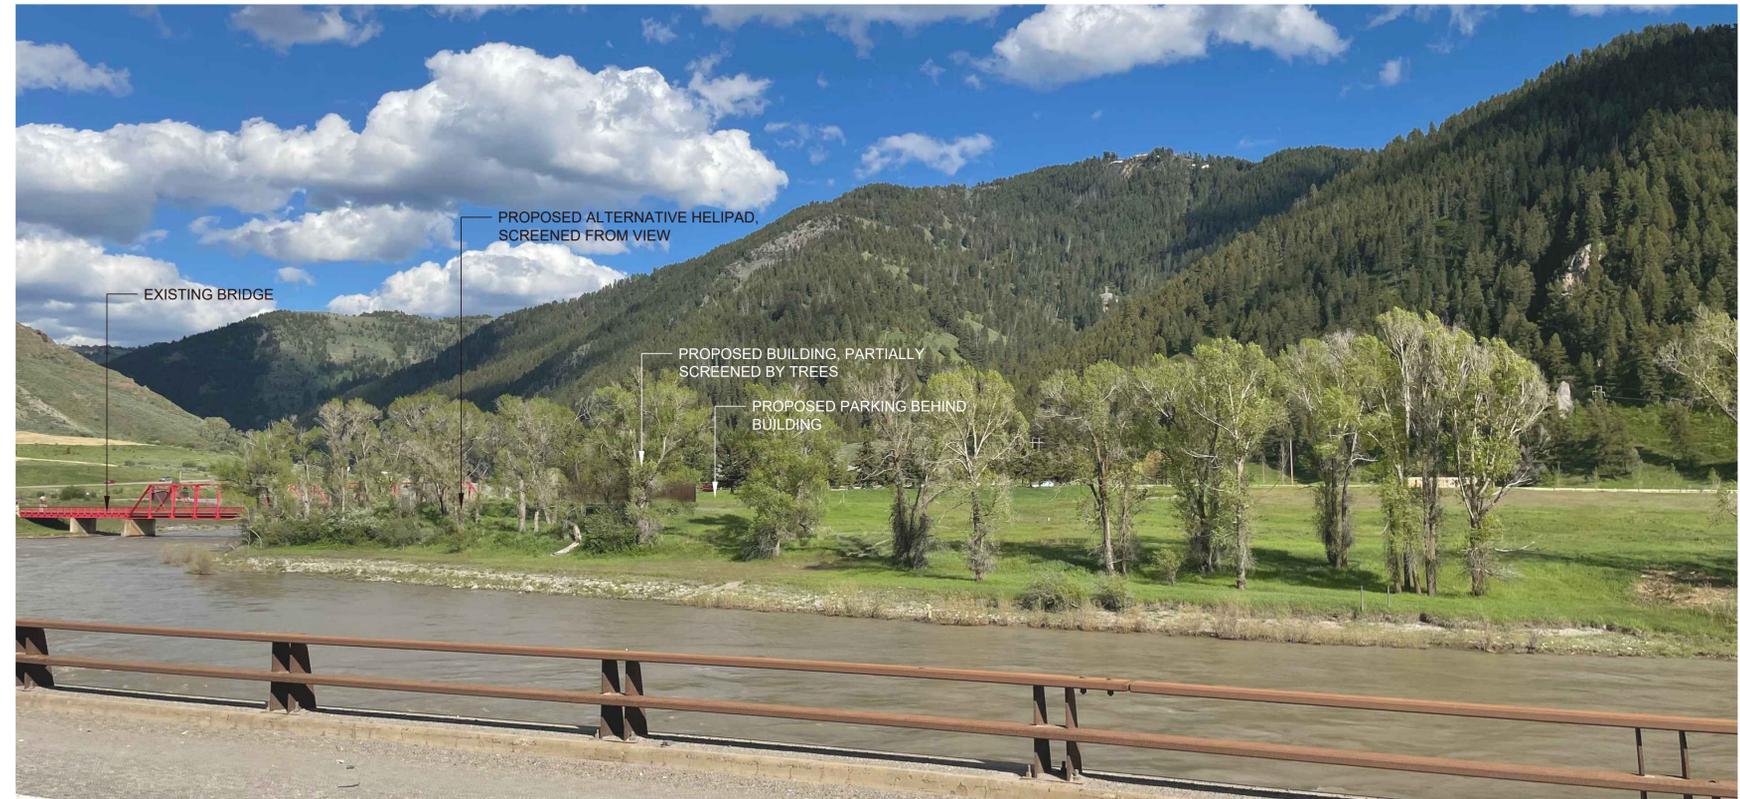
THE PROPOSED DEVELOPMENT PLAN FOR ASTORIA - SRSC EMPLOYEE HOUSING INCLUDES THE CONSTRUCTION OF PARKING LOT, CONNECTING ROAD, AND AN ALTERNATIVE HELICOPTER LANDING SITE ON A PREVIOUSLY DISTURBED AREA OF THE SITE (CURRENTLY GRAVEL MIXED INTO NATURALIZED GRASS). THE PARKING LOT, EXCLUSIVE TO SRSC EMPLOYEES, WILL CONTAIN ENOUGH SPACES FOR A RESIDENTIAL EMPLOYEE DWELLING; THE PATH, EITHER CONCRETE OR CRUSHED GRAVEL, WILL CONNECT THE EMPLOYEE HOUSING TO RIVERBEND ROAD; AND THE ADJACENT ALTERNATIVE HELICOPTER LANDING SITE WILL BE AVAILABLE FOR ANY NECESSARY MEDICAL EVACUATIONS, SCREENED AWAY FROM THE MAIN ROAD.

VIEW 2: PROPOSED LANDSCAPE VIEW LOOKING SOUTHEAST

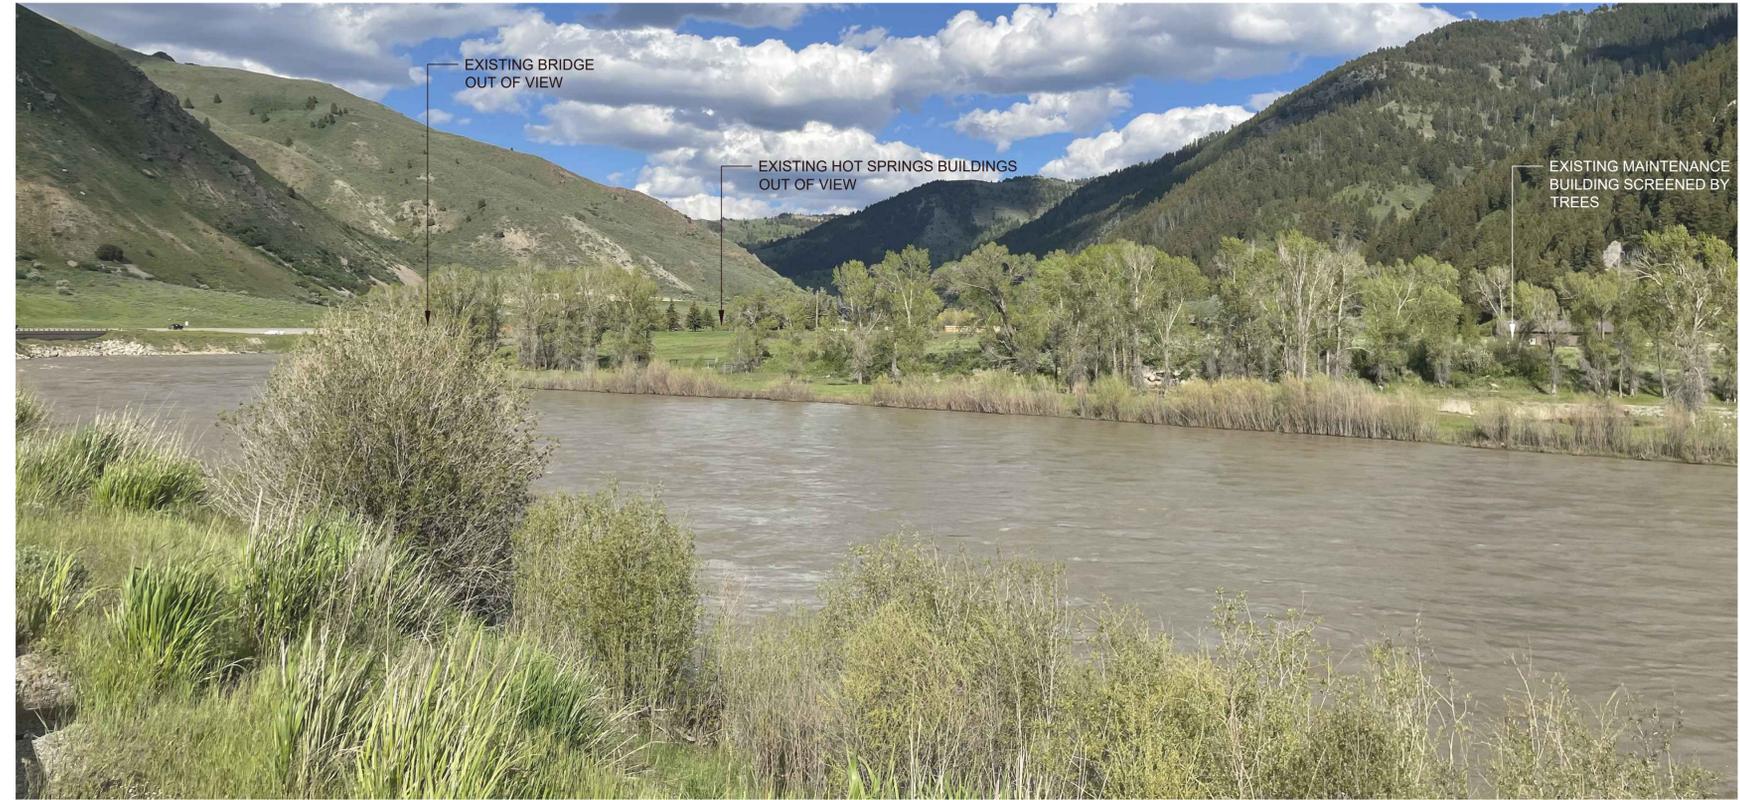
VIEW 3: EXISTING LANDSCAPE VIEW LOOKING EAST

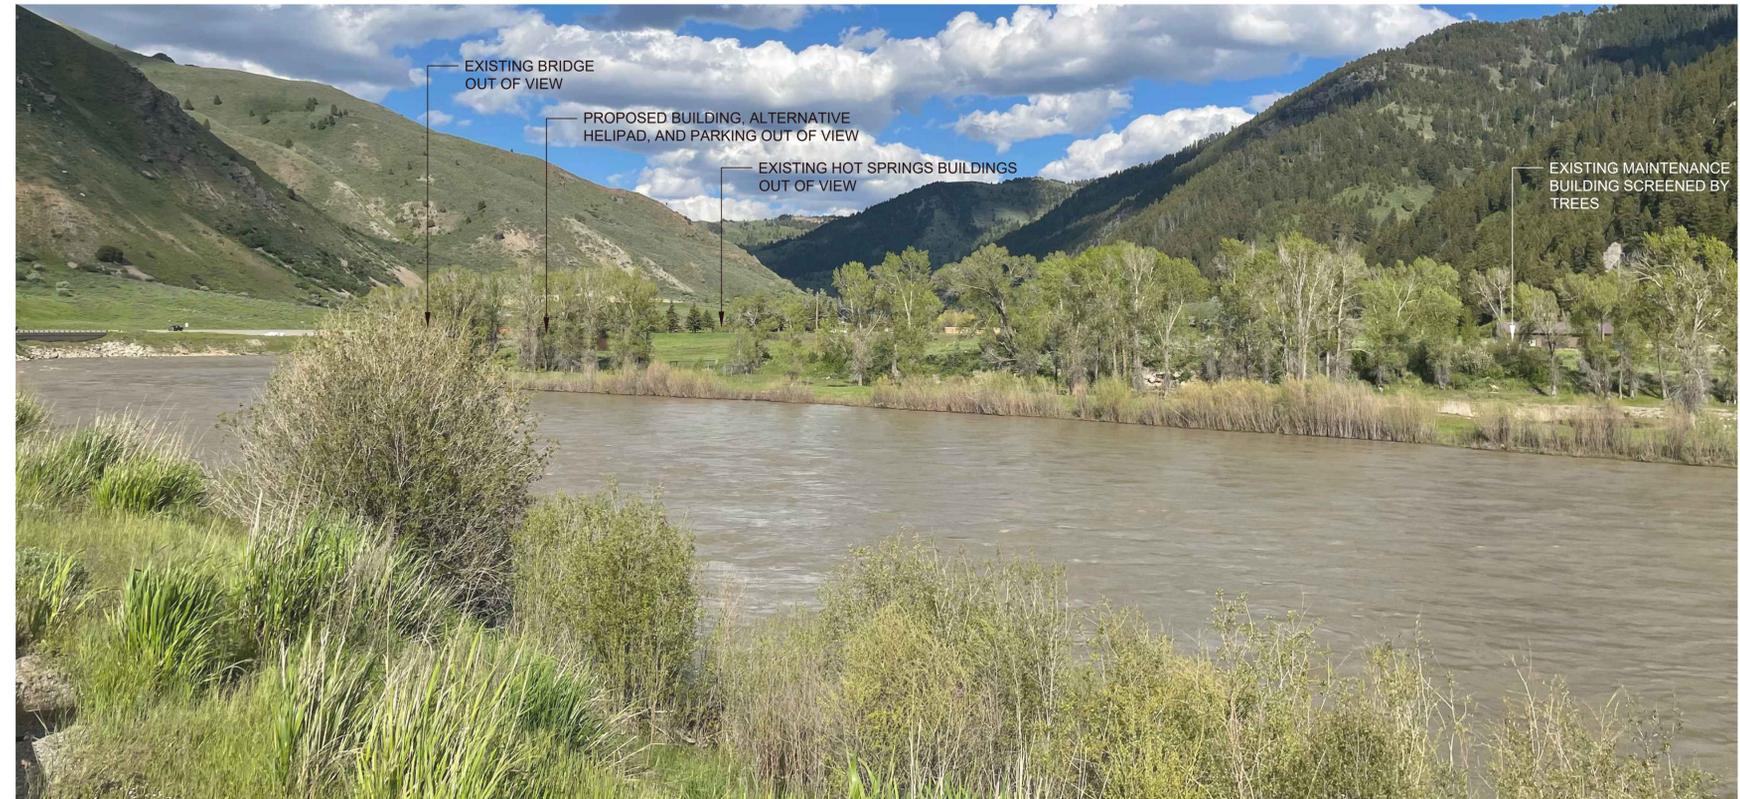
THE PROPOSED DEVELOPMENT PLAN FOR ASTORIA - SRSC EMPLOYEE HOUSING INCLUDES THE CONSTRUCTION OF PARKING LOT, CONNECTING ROAD, AND AN ALTERNATIVE HELICOPTER LANDING SITE ON A PREVIOUSLY DISTURBED AREA OF THE SITE (CURRENTLY GRAVEL MIXED INTO NATURALIZED GRASS). THE PARKING LOT, EXCLUSIVE TO SRSC EMPLOYEES, WILL CONTAIN ENOUGH SPACES FOR A RESIDENTIAL EMPLOYEE DWELLING; THE PATH, EITHER CONCRETE OR CRUSHED GRAVEL, WILL CONNECT THE EMPLOYEE HOUSING TO RIVERBEND ROAD; AND THE ADJACENT ALTERNATIVE HELICOPTER LANDING SITE WILL BE AVAILABLE FOR ANY NECESSARY MEDICAL EVACUATIONS, SCREENED AWAY FROM THE MAIN ROAD.

VIEW 3: PROPOSED LANDSCAPE VIEW LOOKING EAST

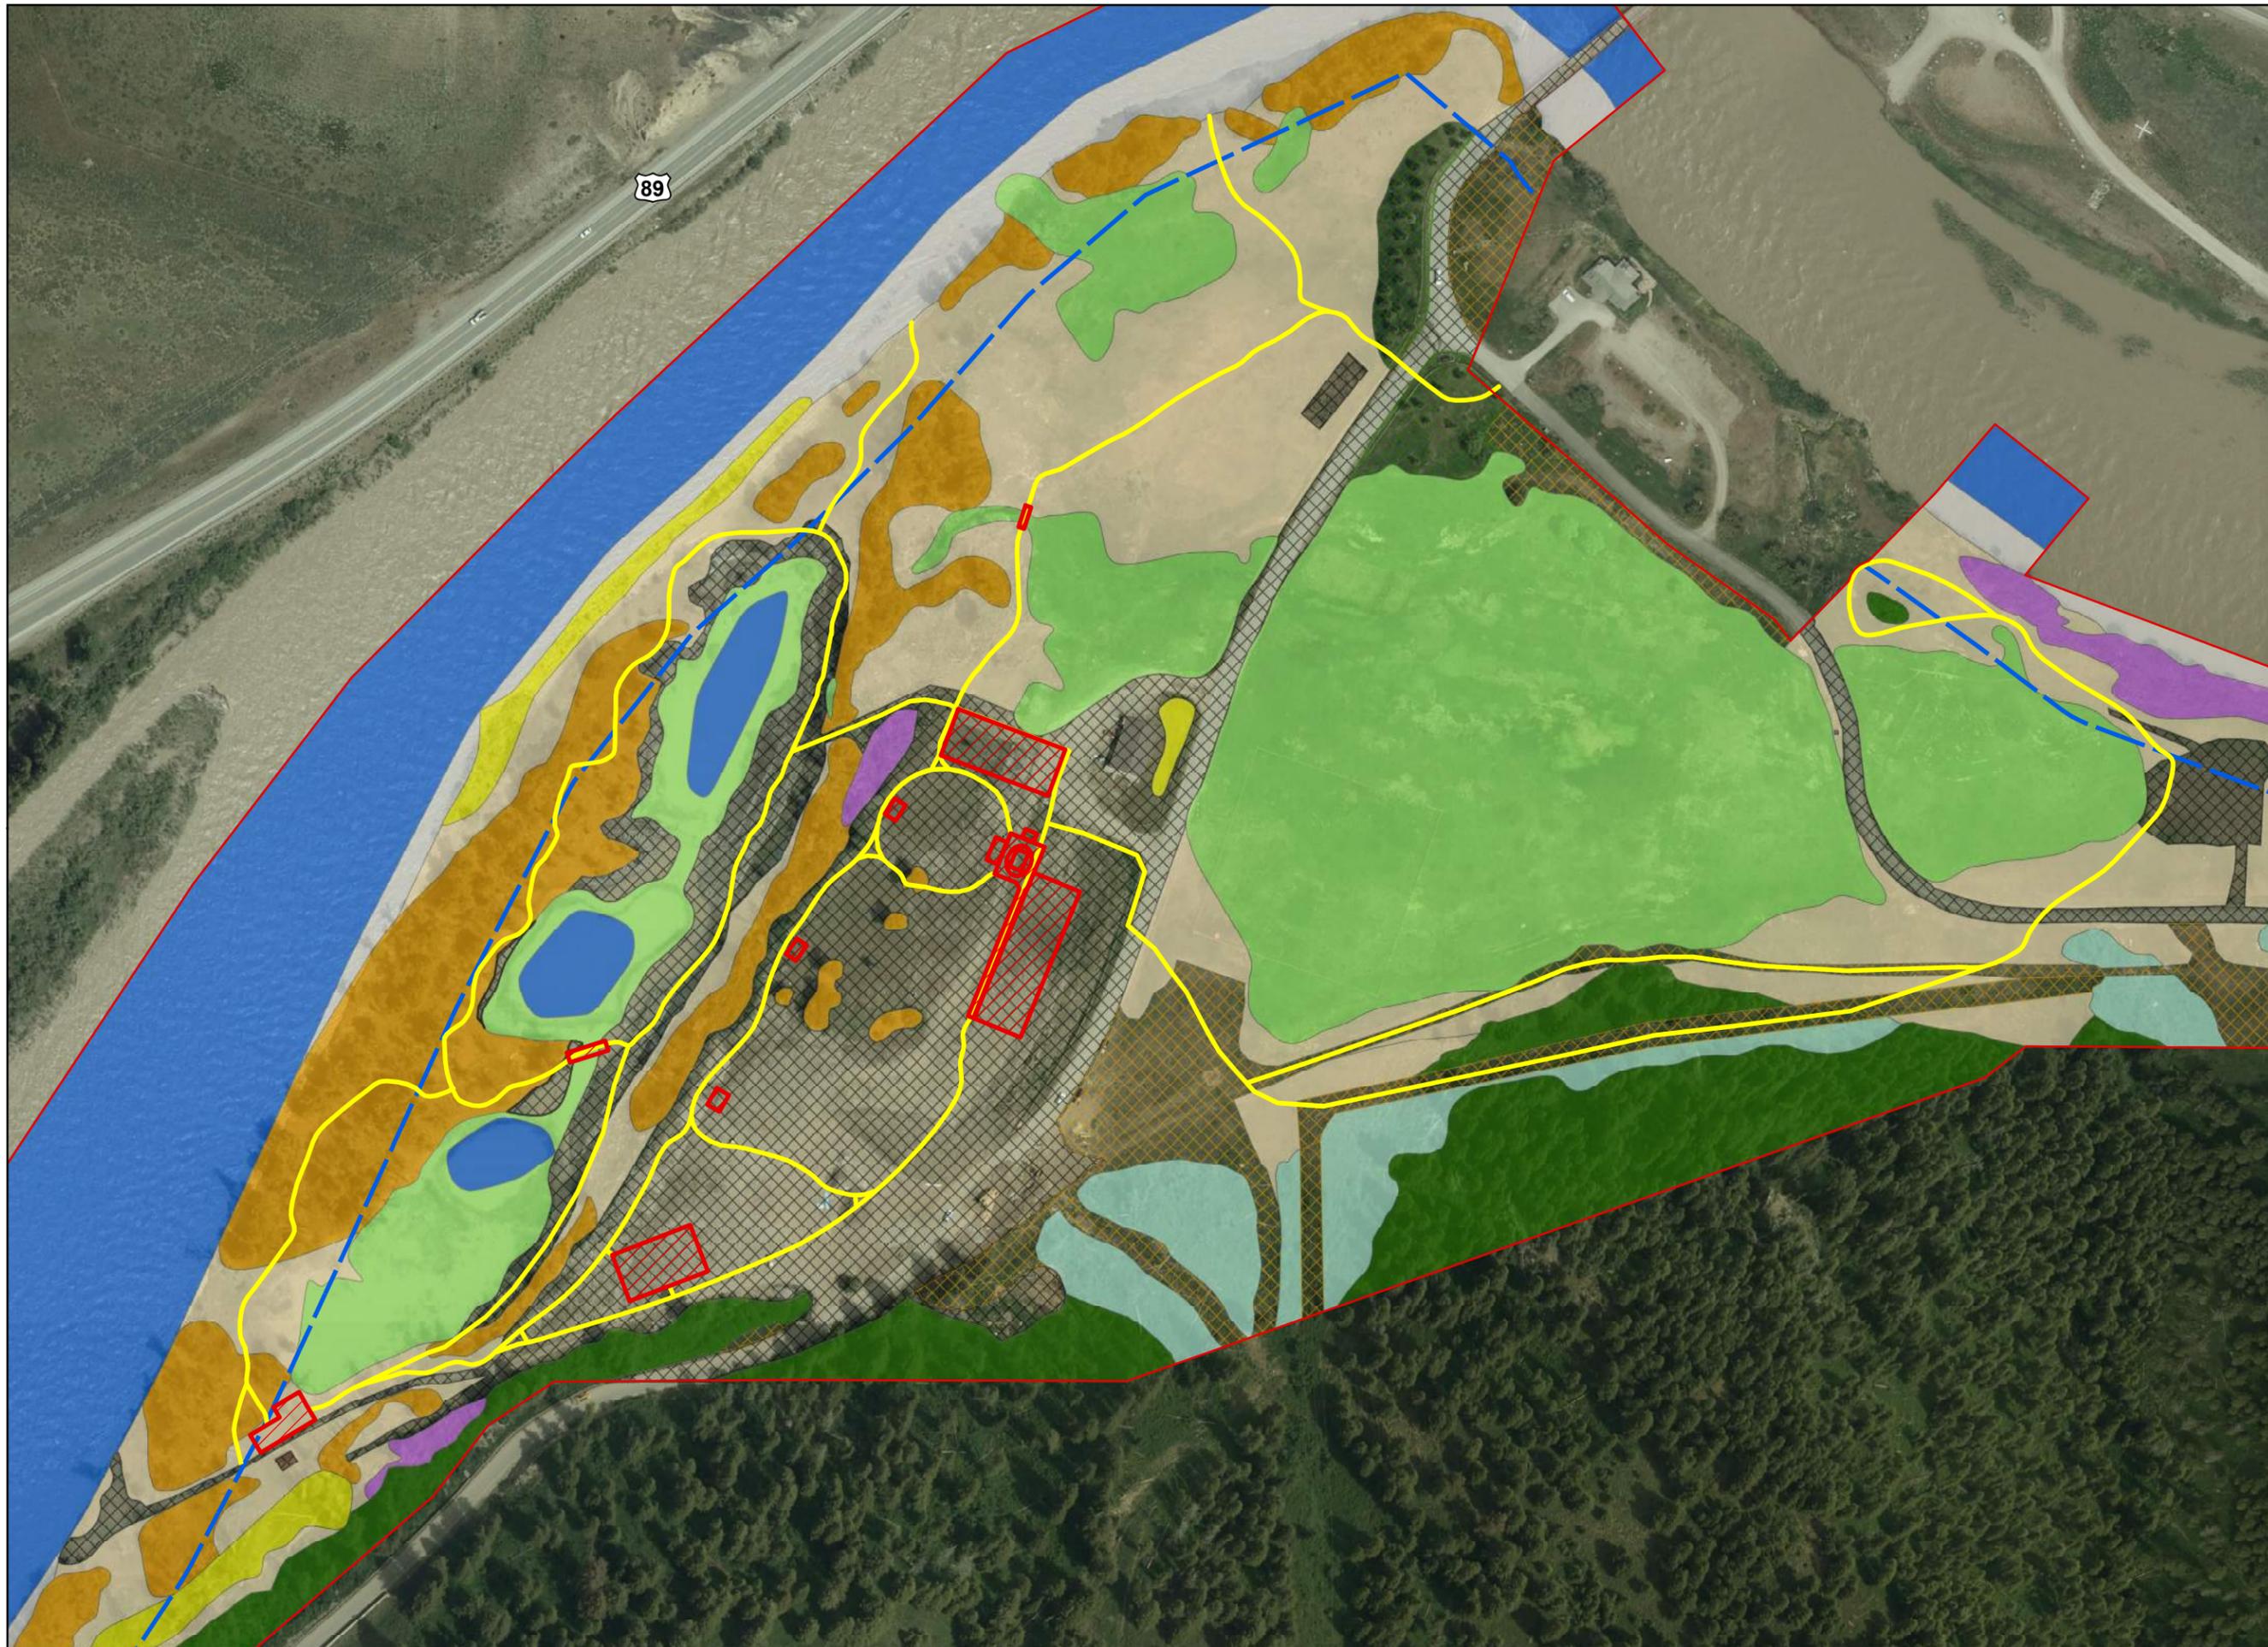
Figure 7:
Proposed Phase II
Development and
Vegetative Cover

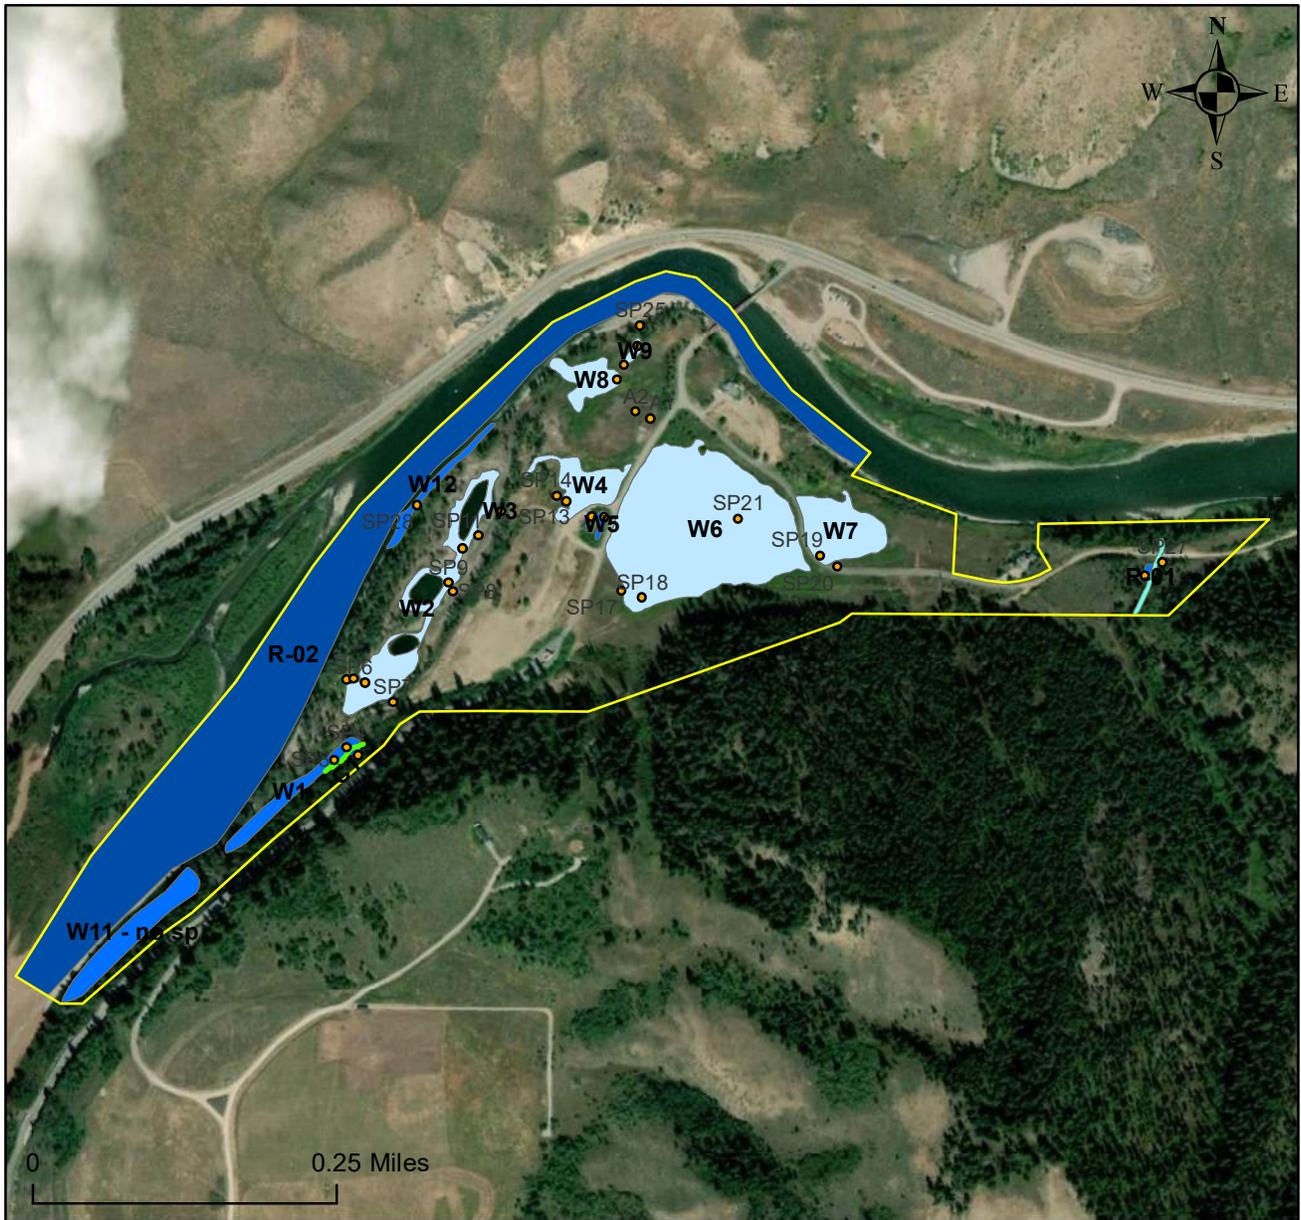
Figure 4. Aquatic resource inventory including wetland delineation for the Astoria Hot Springs Park, Teton County, WY.

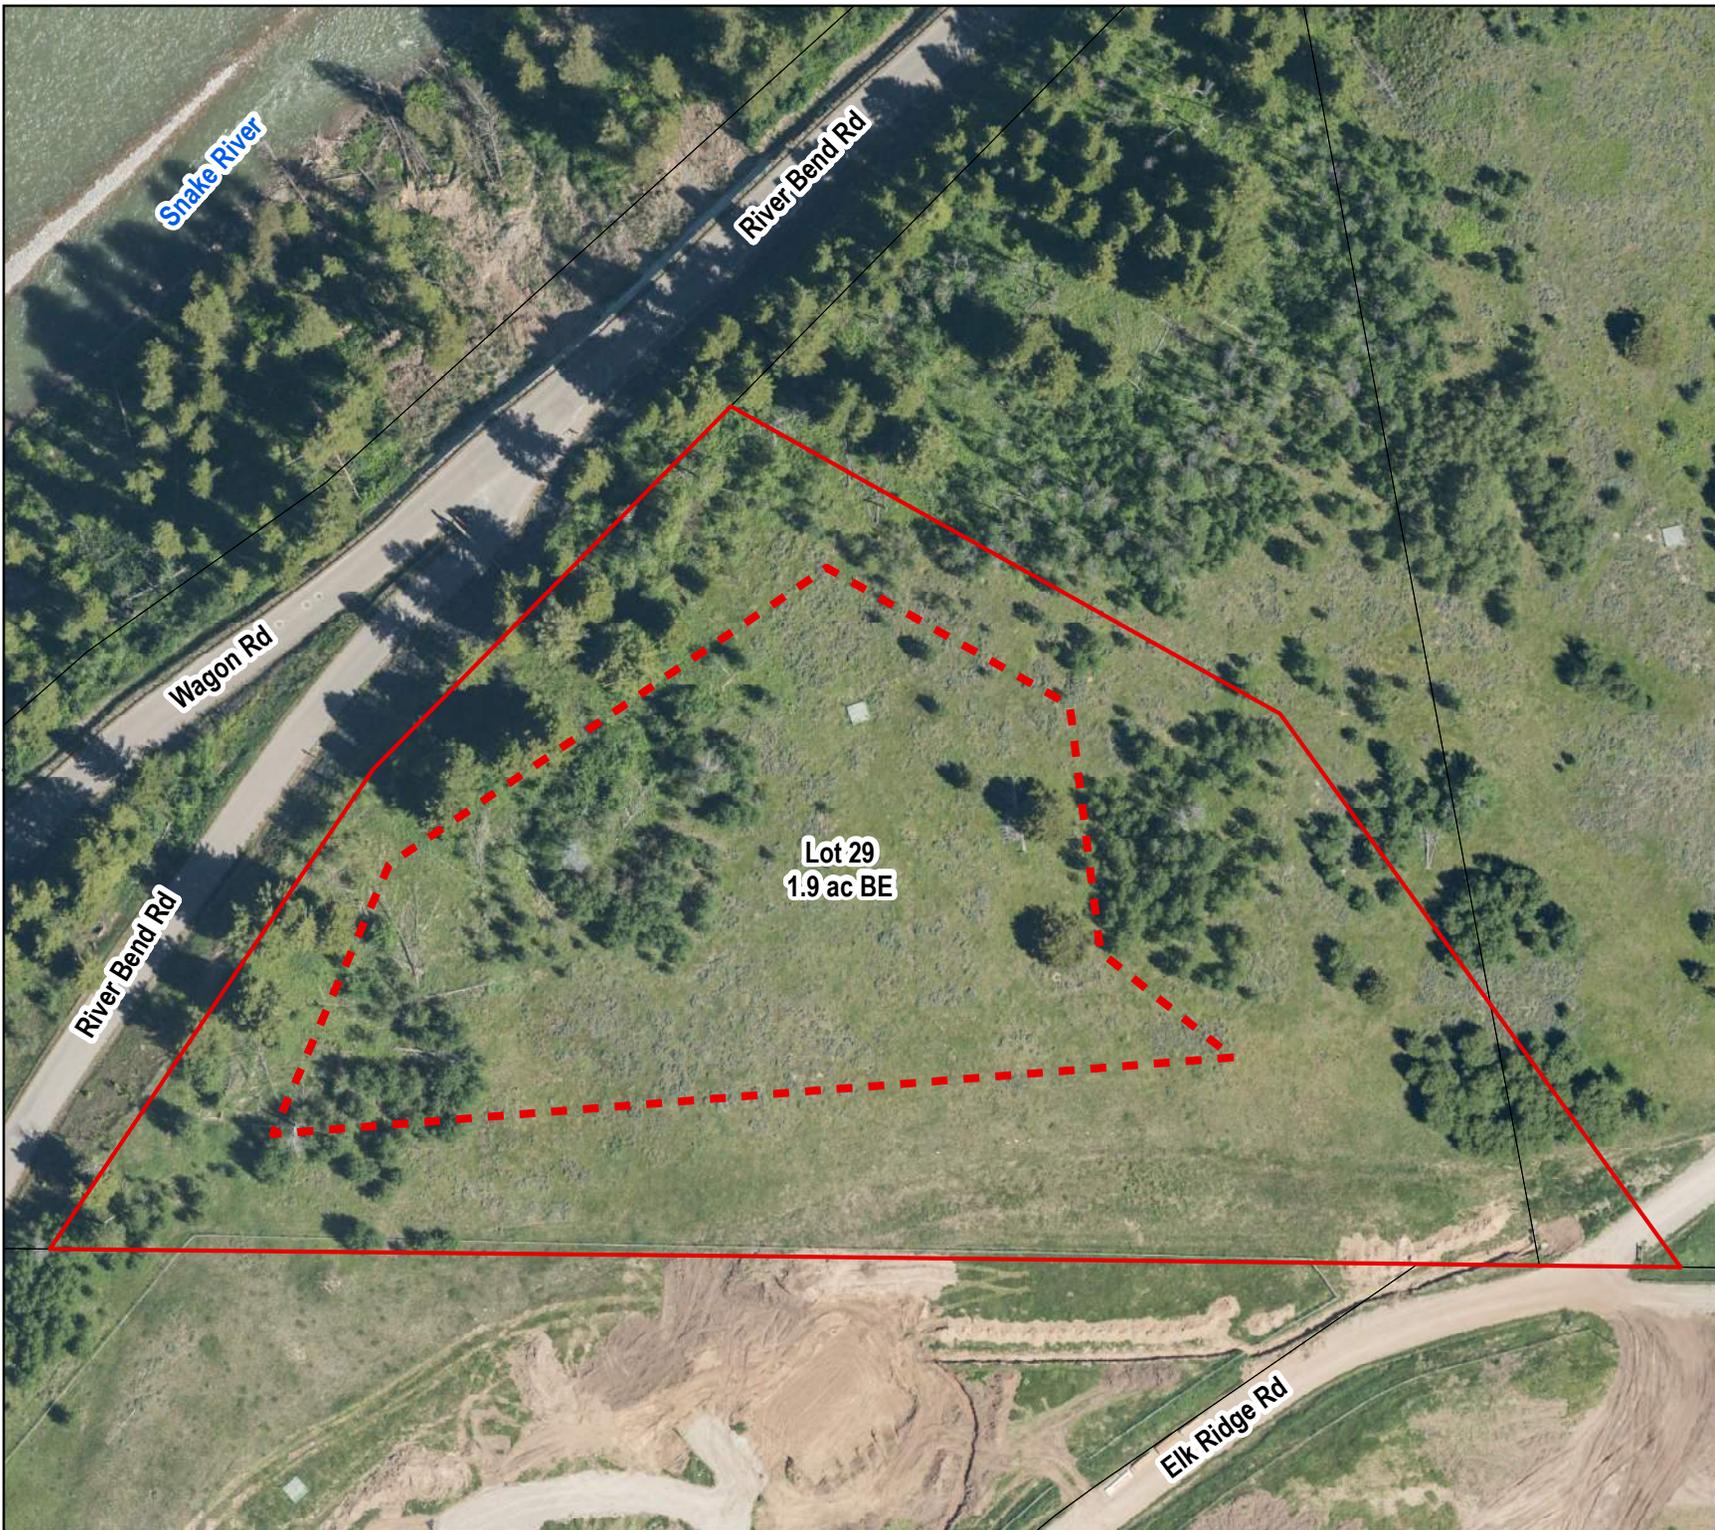
Figure 5:
Proposed Building
Envelope and Lot

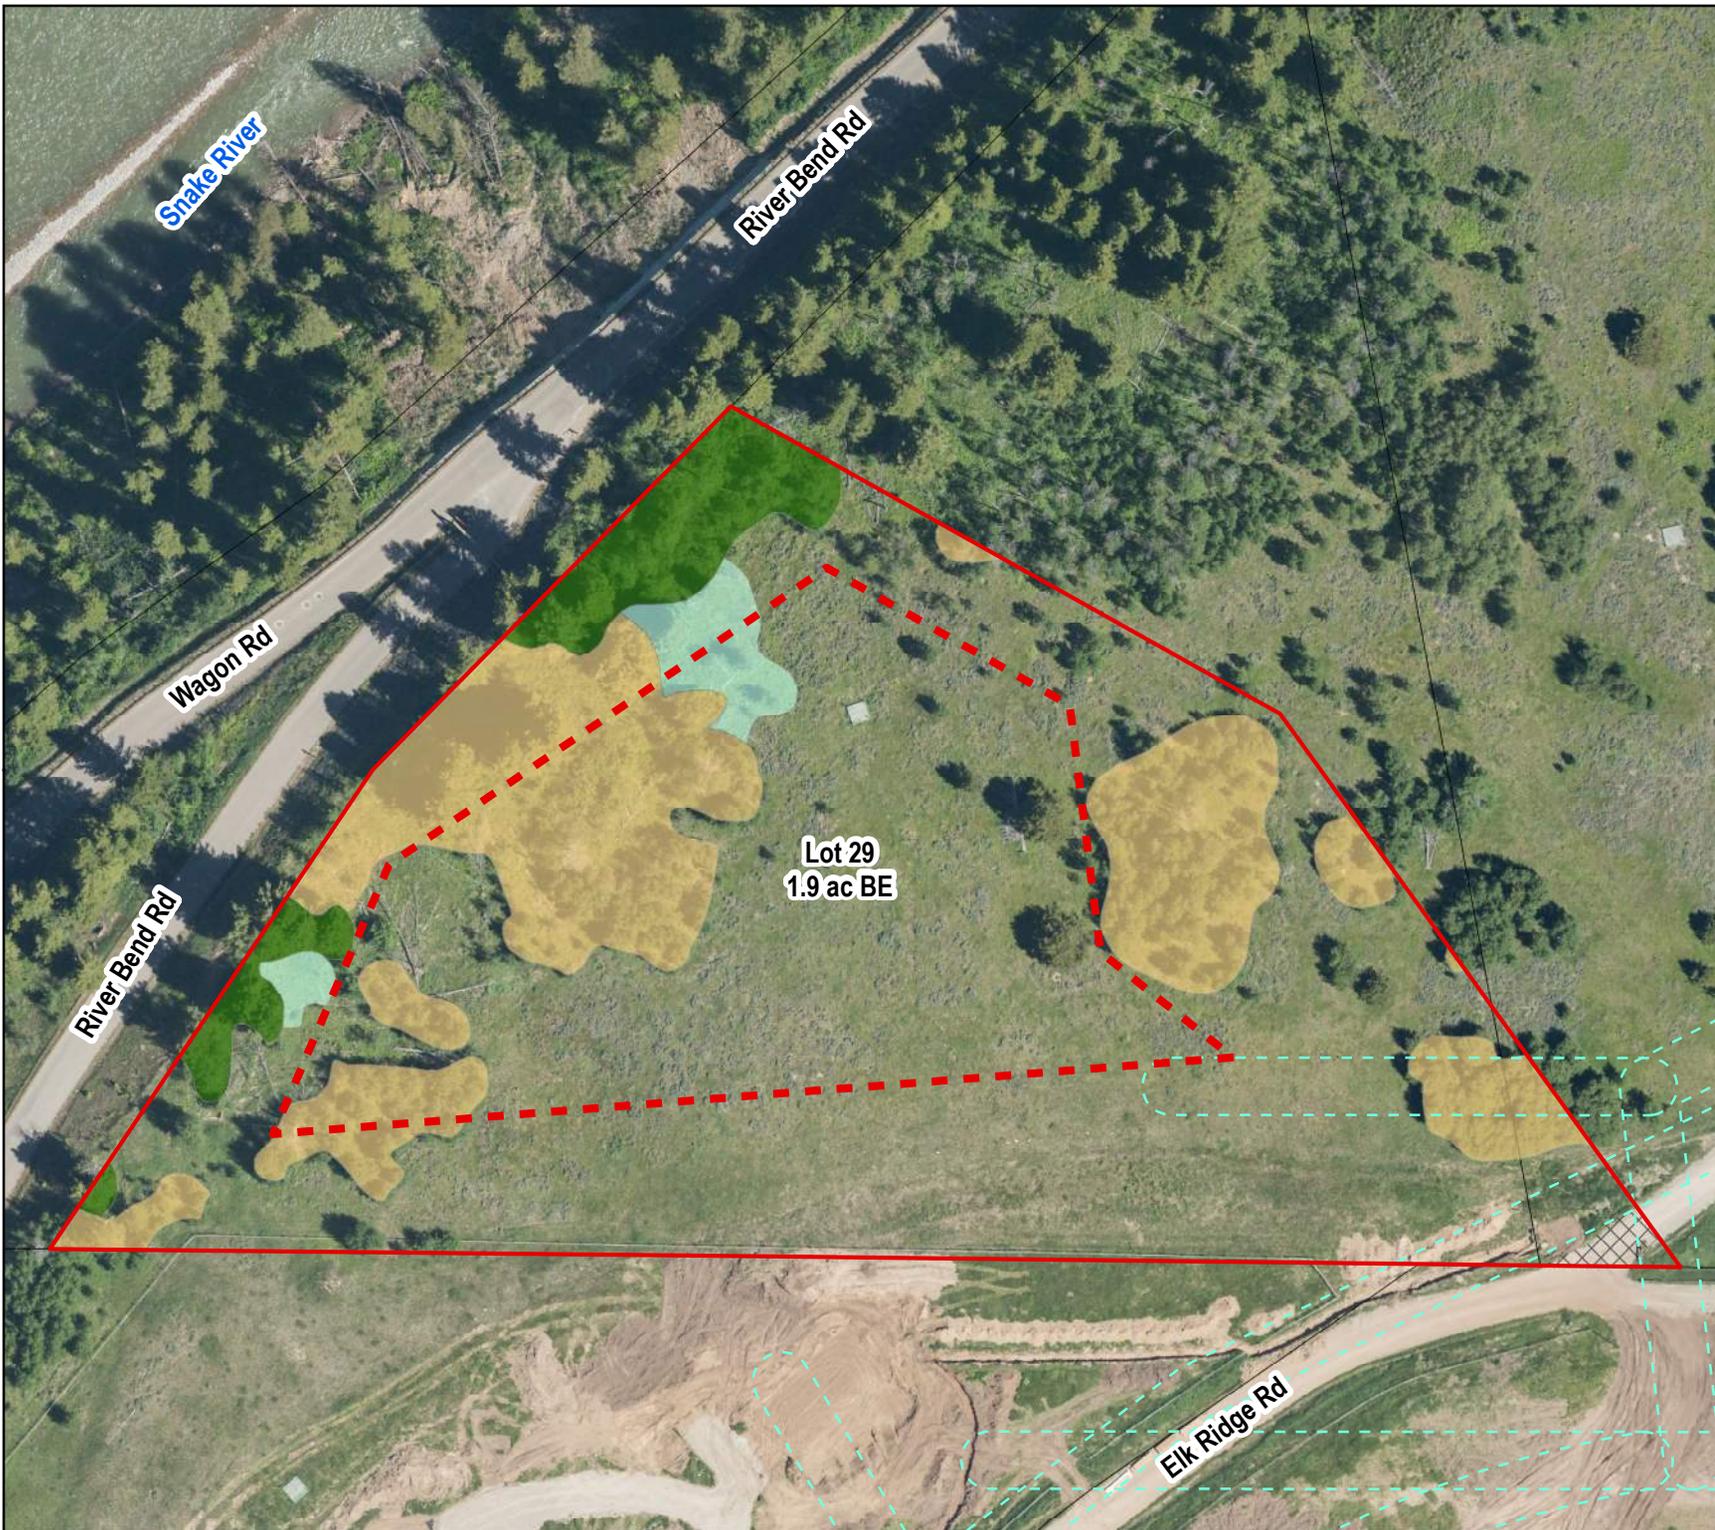
Figure 6:
Proposed Building
Envelope and Vegetative
Cover Types

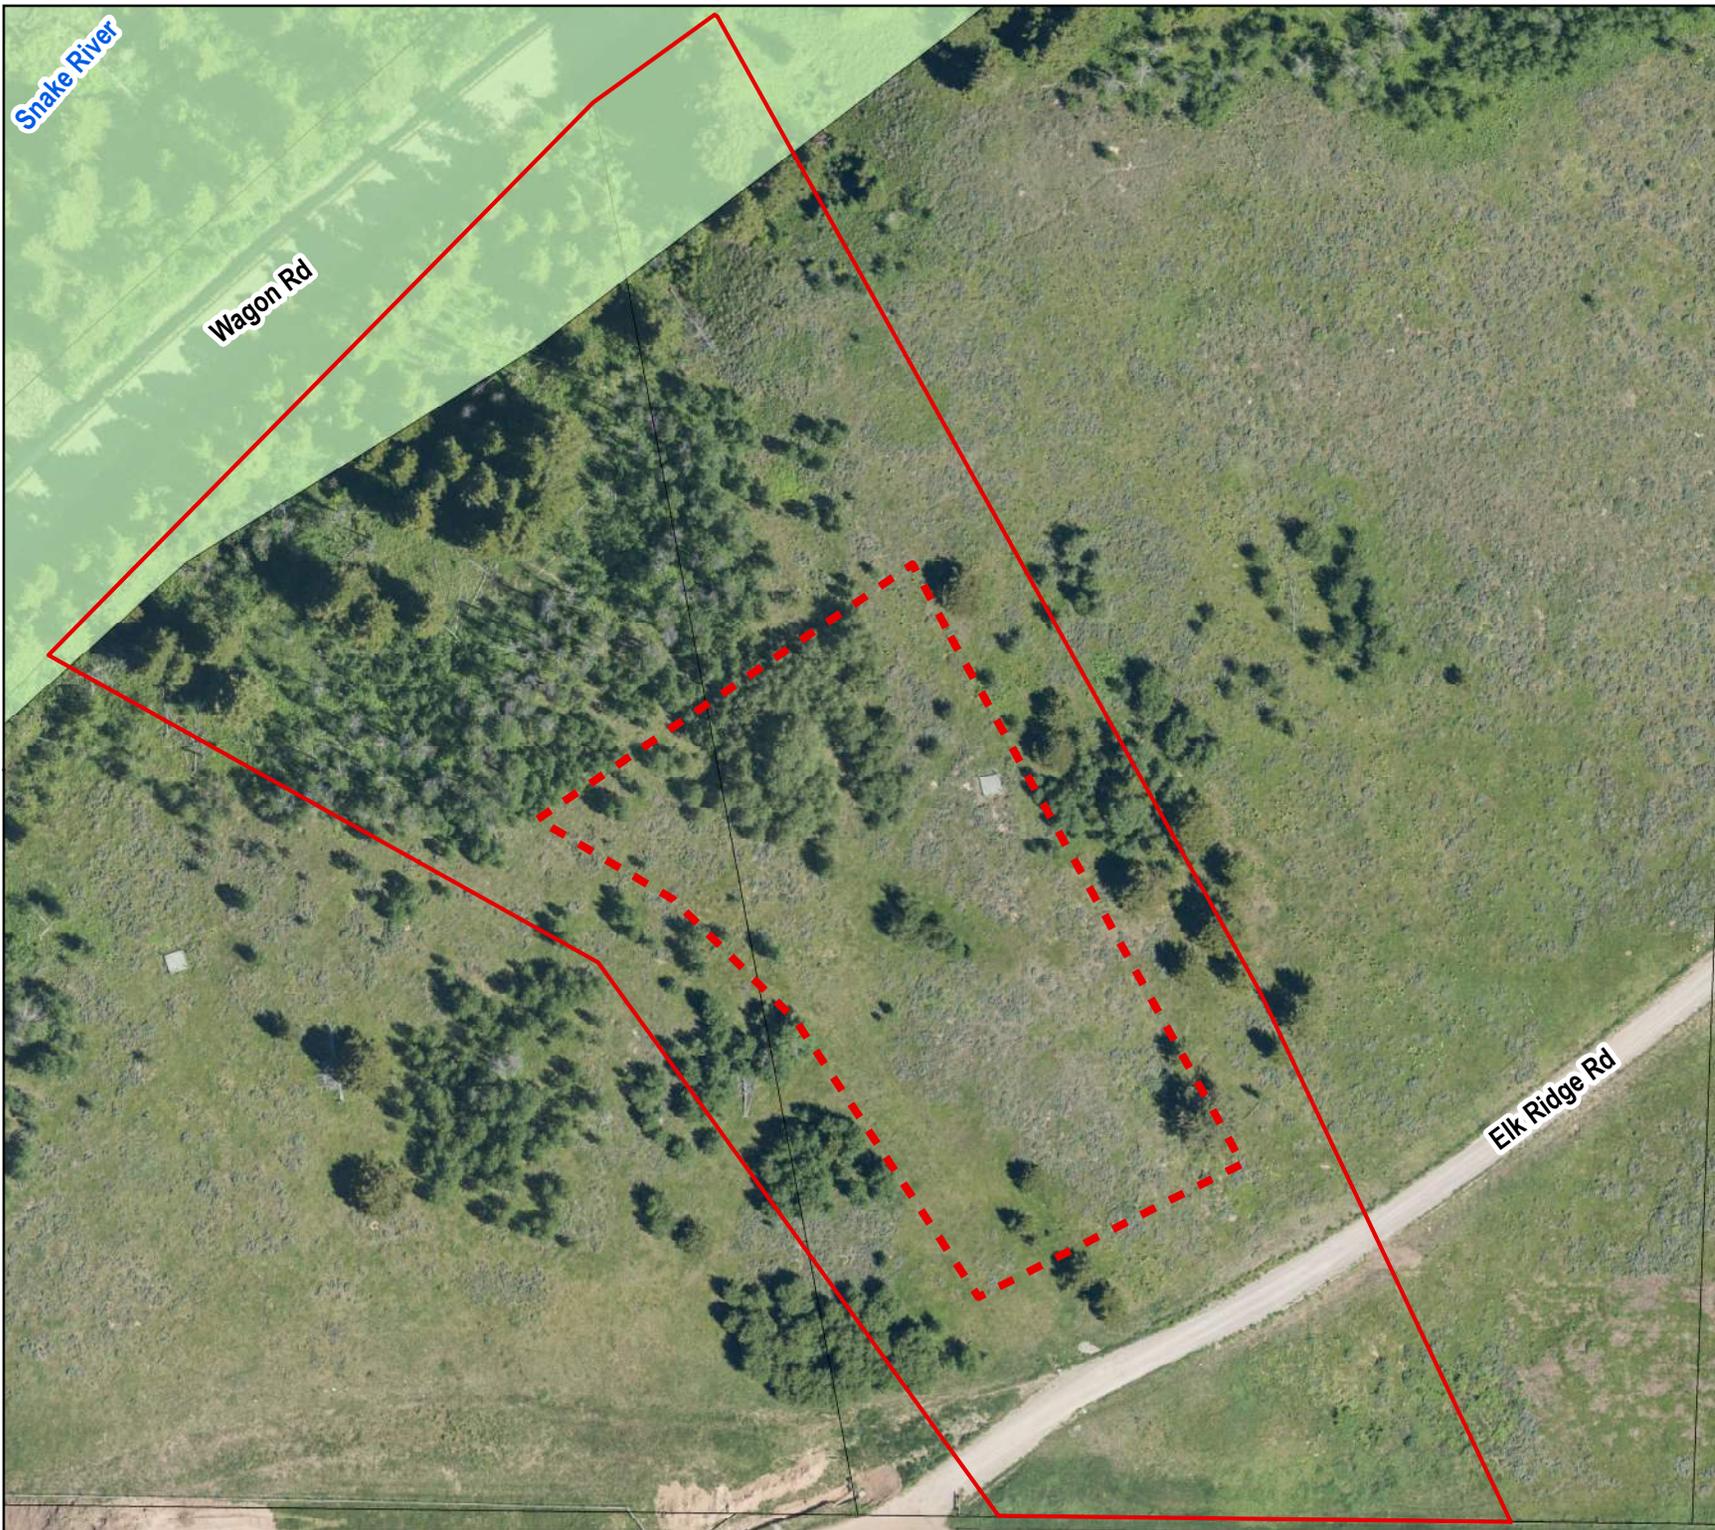
Figure 5:
Proposed Building
Envelope and Lot
