TRANSMITTAL MEMO

<p>Date: January 25, 2023</p> <hr/> <p>Item #: P23-015</p> <hr/> <p>Planner: Paul Anthony</p> <p>Phone: 733-0440 ext. 1305</p> <p>Email: panthony@jacksonwy.gov</p> <hr/> <p>Owner: Christopher Swann & Snake River Bend Ranch LLC 3060 Peachtree Rd. NW STE 1080 Atlanta, GA 30305</p> <p>Applicant: Jorgensen Associates, Inc. PO Box 9550 Jackson WY 83002</p>	<p style="text-align: center;">REQUESTS:</p> <p>Teton County is submitting a request for a Town of Jackson review of an Amended PUD and Development Plan associated with Snake River Canyon Ranch Resort located at 12455 S River Bend Rd, 985 W Elk Ridge Rd, and W Elk Ridge Road, PIDN: 22-39-16-32-4-01-005, 22-39-16-32-4-02-001; 22-39-16-32-4-02-002</p> <p>For questions, please call Paul Anthony at 733-0440, x1303 or email to the address shown below. Thank you.</p>
<p>Please respond by: February 15, 2023 (with Comments)</p>

PROJECT TITLE:
**SLAKE RIVER SPORTING CLUB
 LOT 23, THE RIVER HOMES
 SLAKE RIVER CANYON RANCH
 TETON COUNTY, WYOMING**

SHEET TITLE:
SITE PLAN

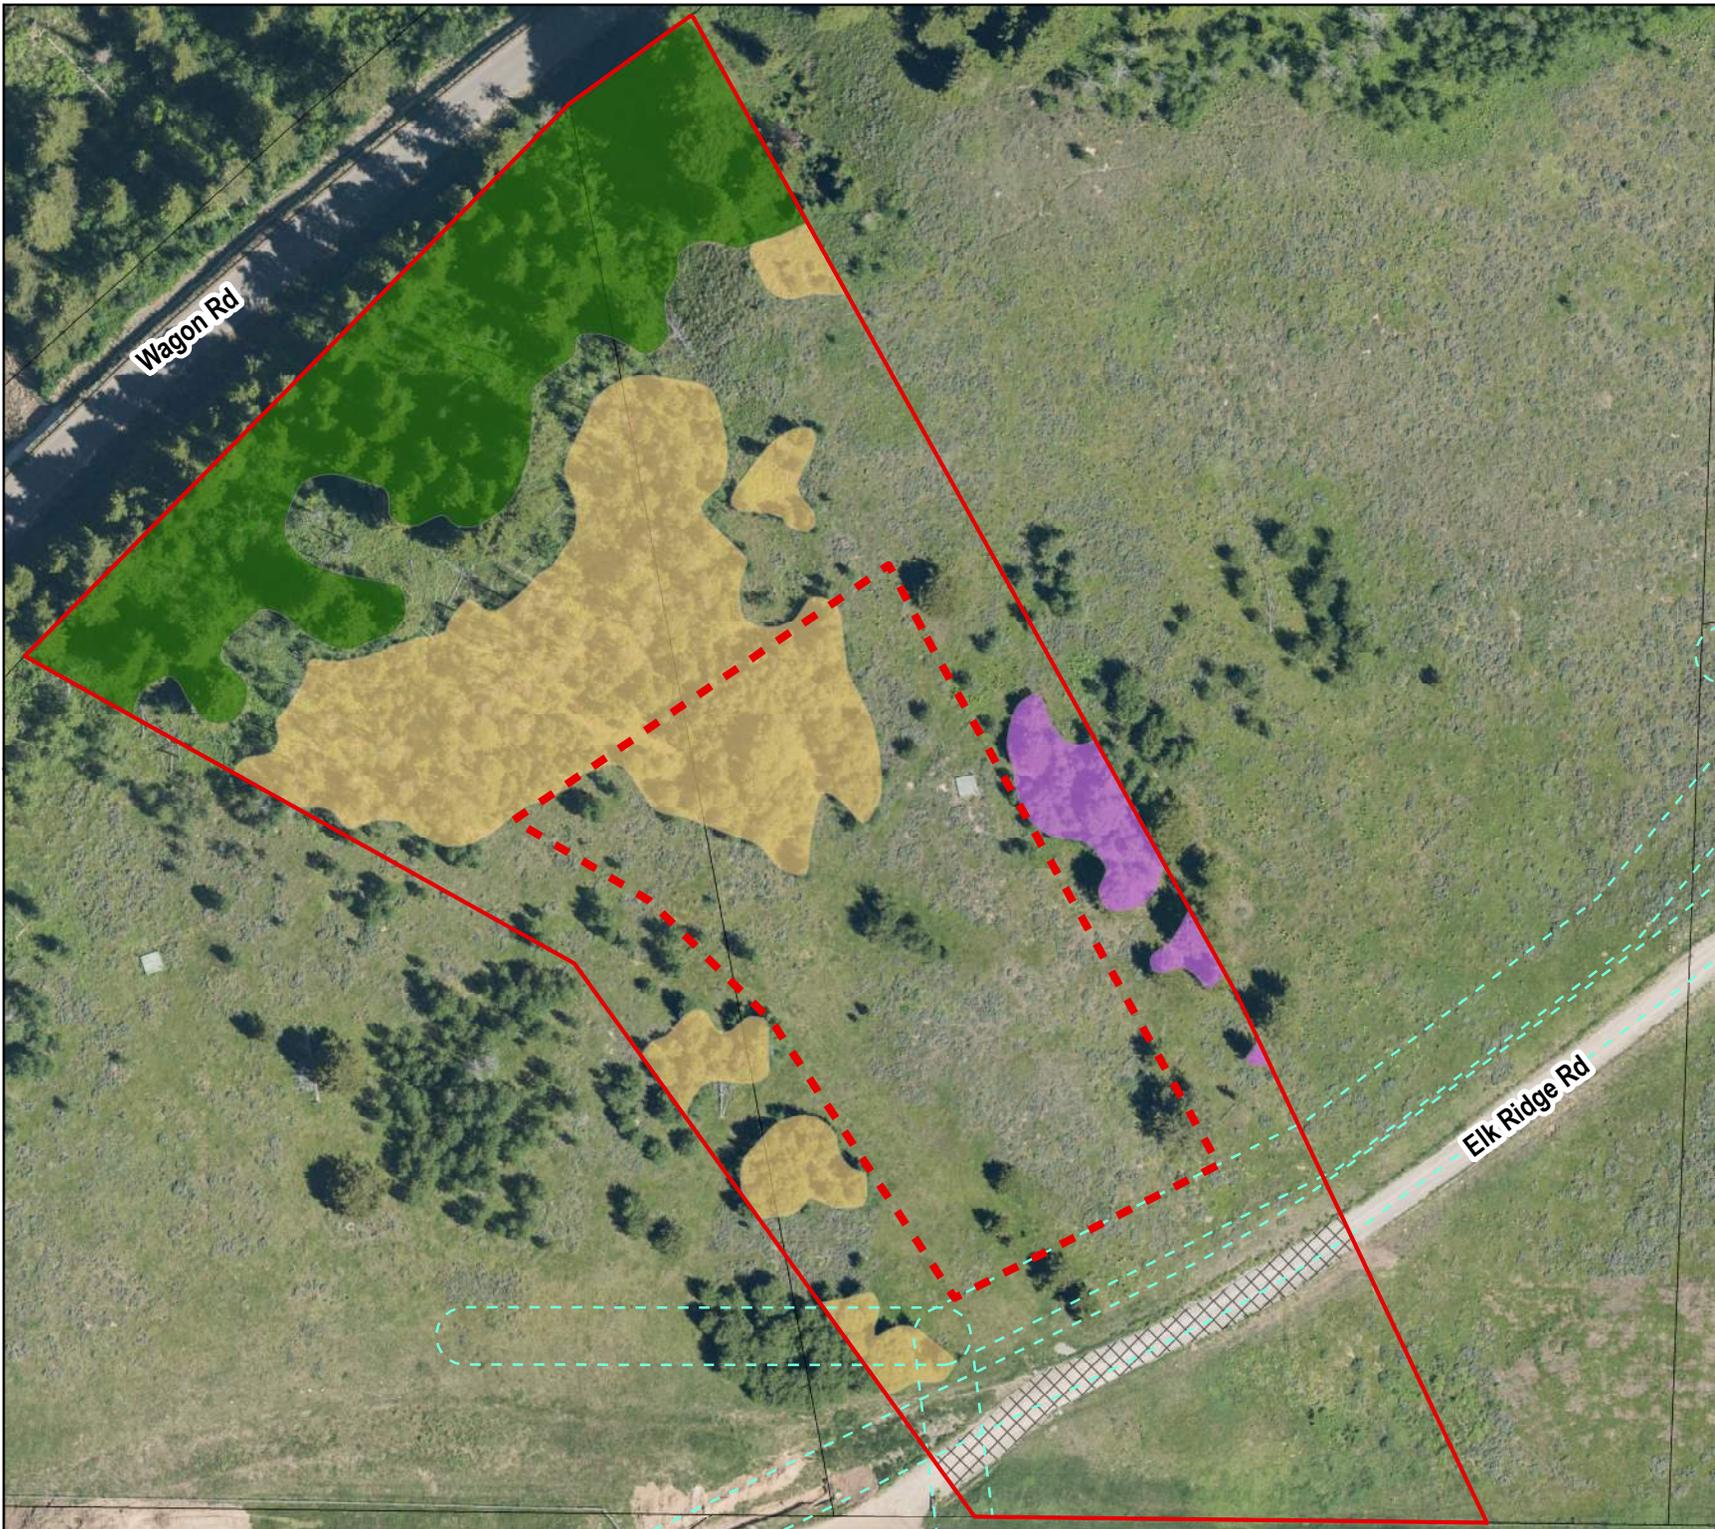
Figure 6:
Proposed Building
Envelope and Vegetative
Cover Types

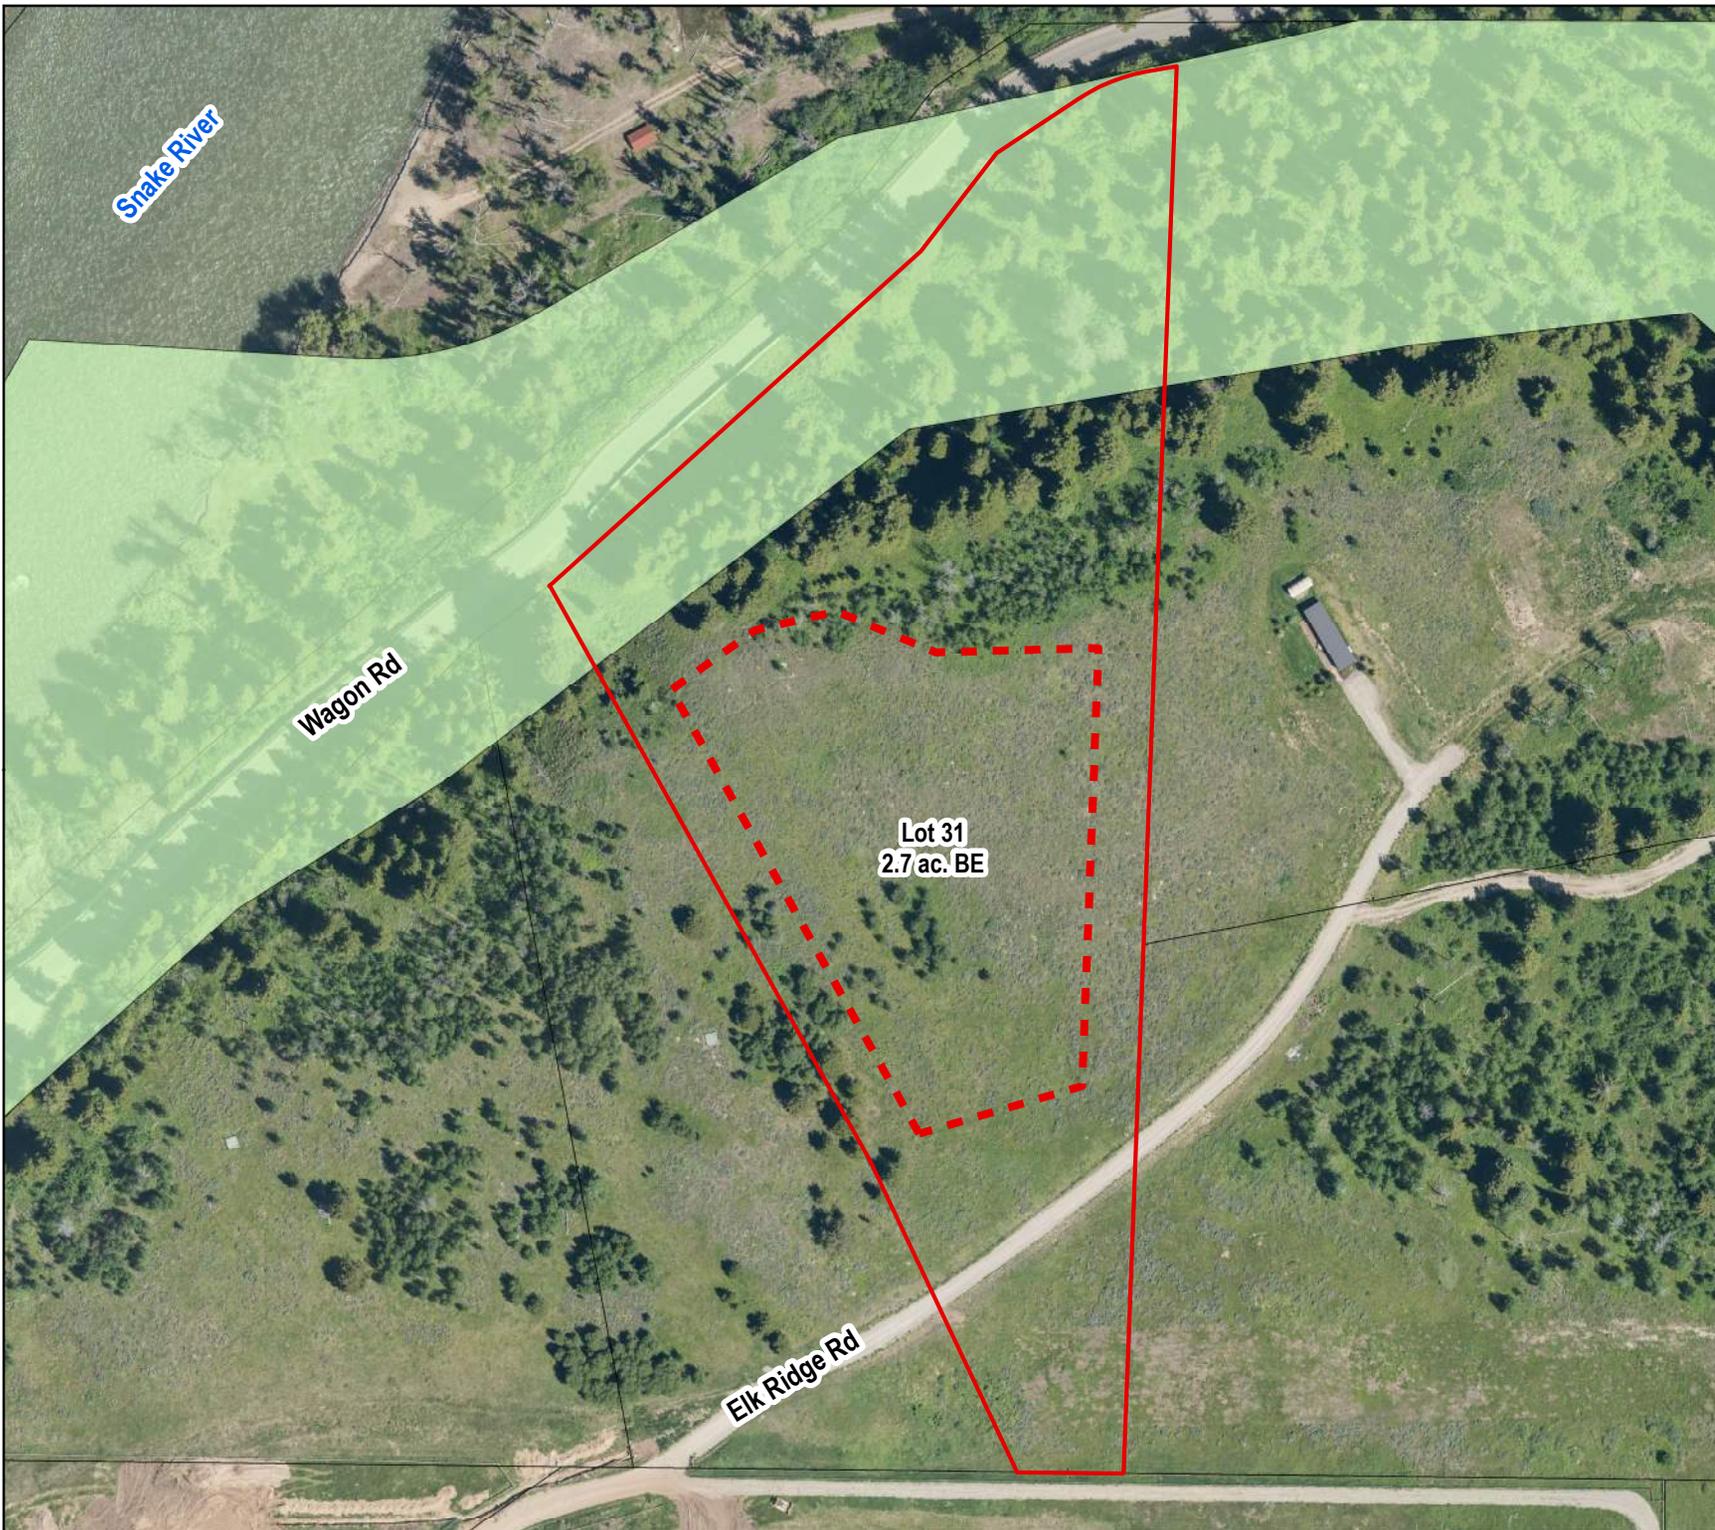
Figure 5:
Proposed Building
Envelope and Lot

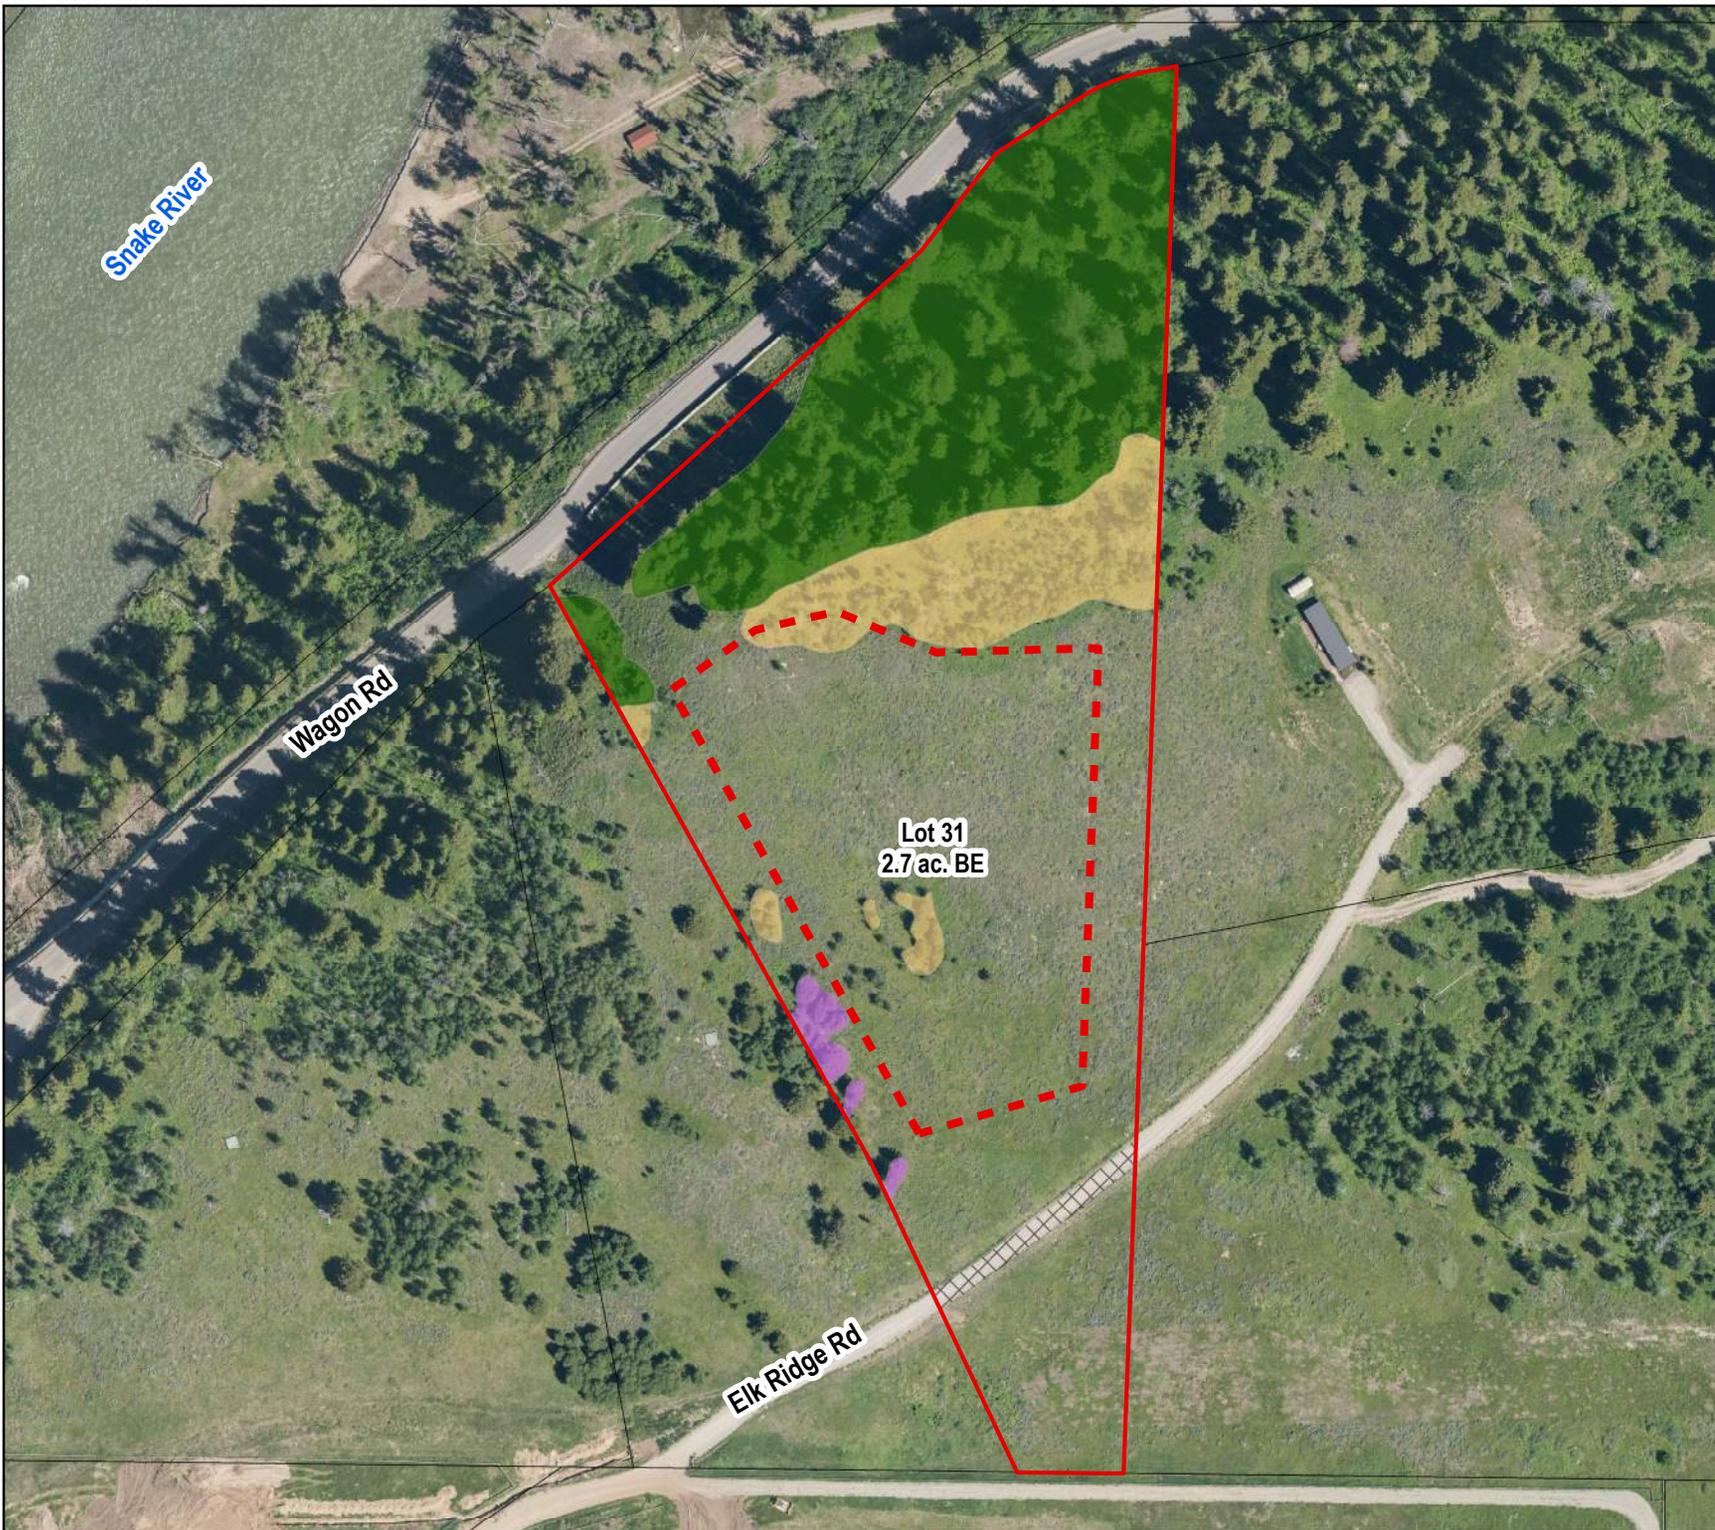
Figure 6:
Proposed Building
Envelope and Vegetative
Cover Types

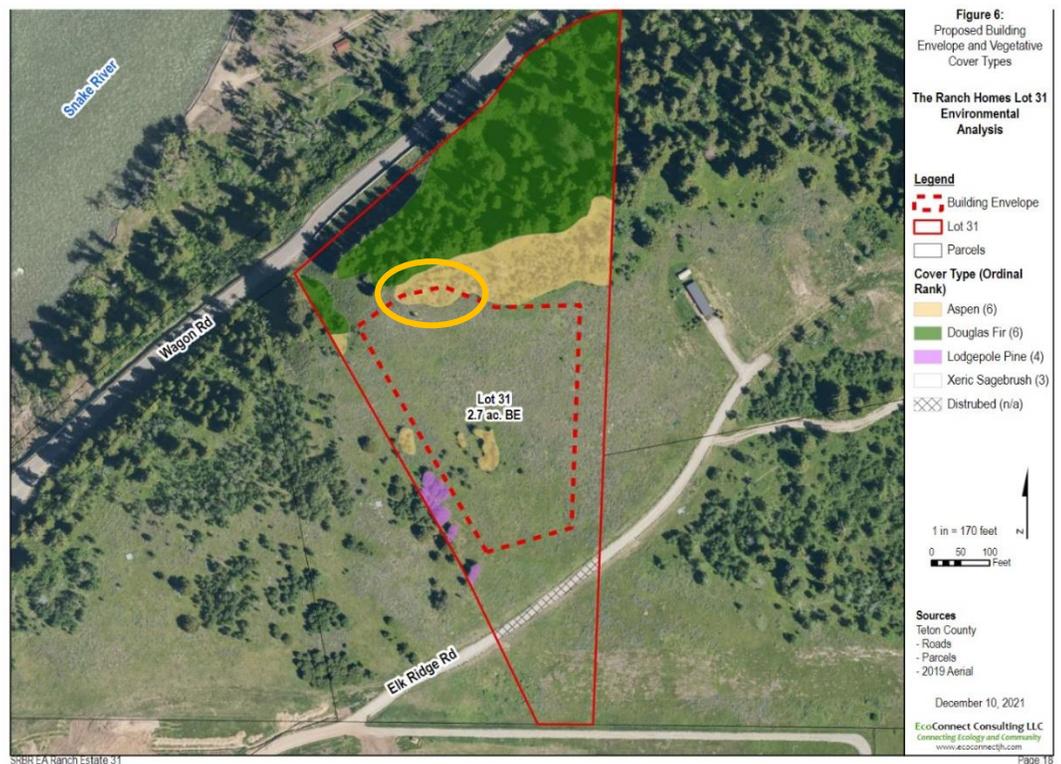
Development impacts are primarily xeric sagebrush with some minor impacts to aspen. There is a small aspen stand in the center of the property that would be impracticable to avoid, and the impacts are minimal. However, the impacts to the larger aspen stand on the north side of the development area would be easy to avoid and do not minimize impacts, and therefore it is recommended that aspen stand be left undisturbed during construction. The figure to the right identifies those aspen trees that are recommended to be left undisturbed.

Figure 1: Identifying "Northern Aspen Stand" within Recommended Building Envelope
